CONSULTANCY REPORT ON THE ABADAN PROJECT OF ABVARZAN Co.  
R.J.Oosterbaan, International Institute for Land Reclamation and Improvement (ILRI),  
Wageningen, The Netherlands  
12 September 2004  
on website [www.waterlog.info](http://www.waterlog.info)

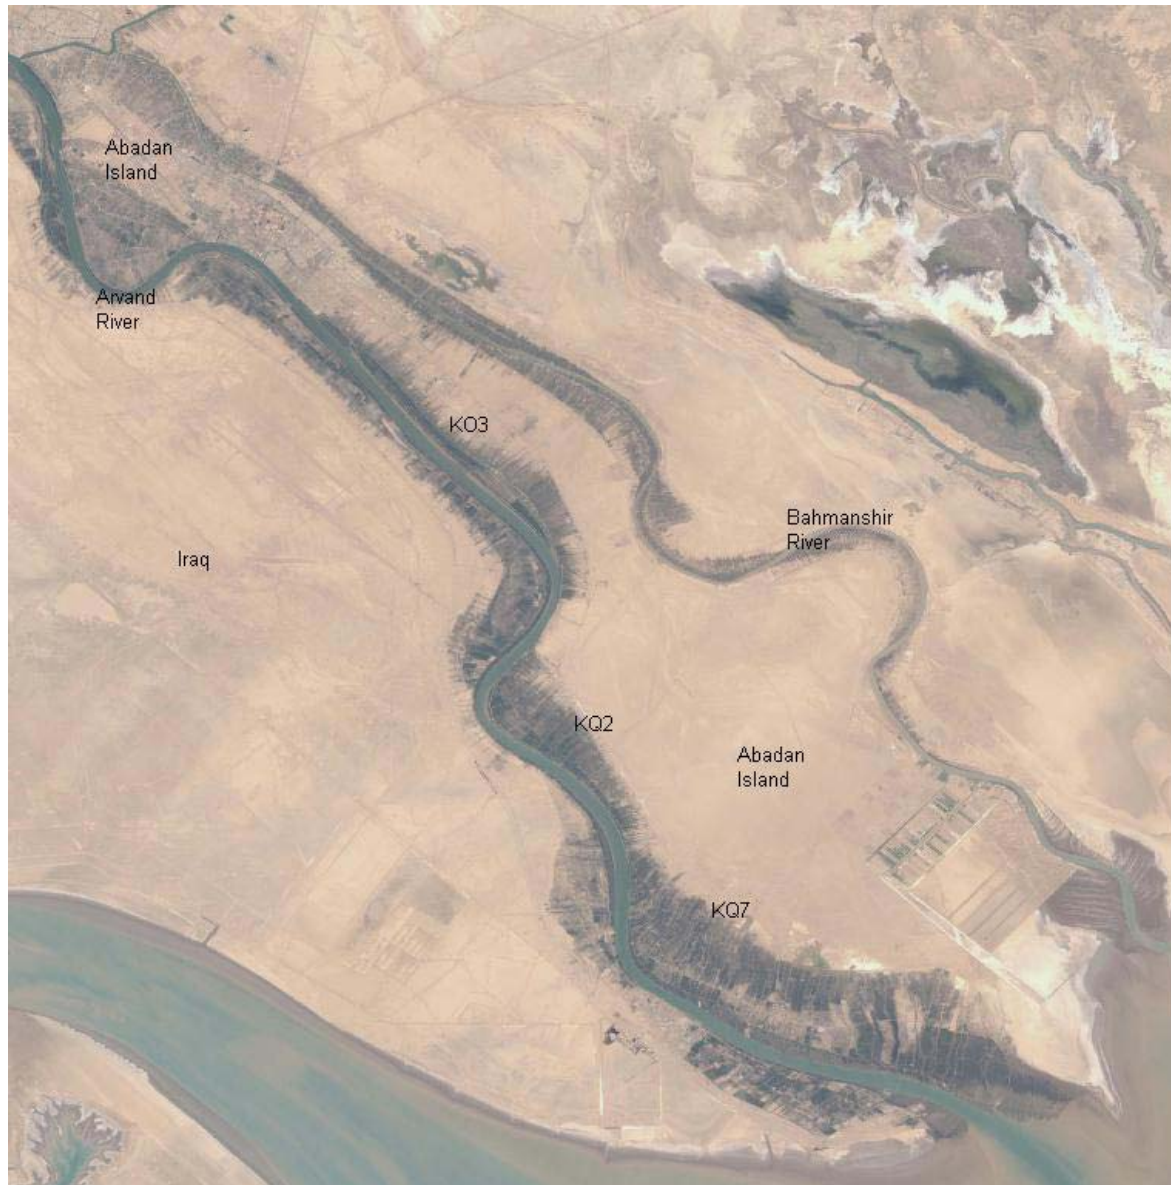
Figure 1. Satellite image of palm tree belts on Abadan Island along Arvand and Bahmanshir Rivers showing approximate location of experimental and study Areas KQ3, KQ2, and KQ7

Of old, the irrigation of the trees occurs by a system of tidal canals (figure 1), from which river water infiltrates into the soil at high tide. The trees are able to grow on the infiltrated water.

The palm tree belt stretches along the Arvand River over a distance of about 40 km and is bounded in the interior by a road. The width of the belt varies from 2 to 6 km, and on average it is 4 km. Figure 1 shows that the width is greater in the concave parts of the river bends and smaller in the convex parts. The convex parts probably have higher levees and topography.

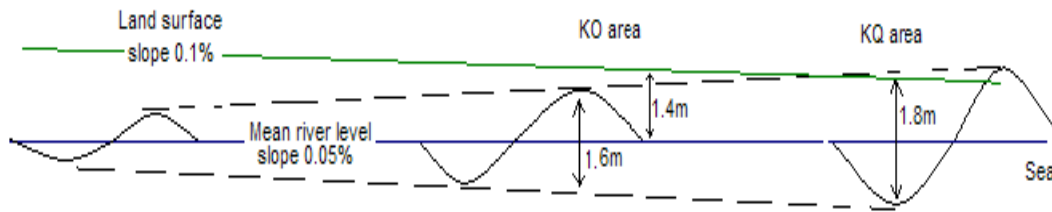
Figure 2. Attenuation (flattening) of the tidal fluctuation in the river in upstream (inland) direction from the sea

Tidal fluctuations in river mouths are greatest near the shore and become gradually smaller upstream. In Arvand River, at the mouth in the KQ area, the tidal fluctuation varies between 1.7 and 1.9 m (say 1.8 m). Upstream, at the KO area, the fluctuation ranges from 1.5 to 1.7 m (say 1.6 m), due to the attenuation of the tidal wave in upstream direction (figure 2).

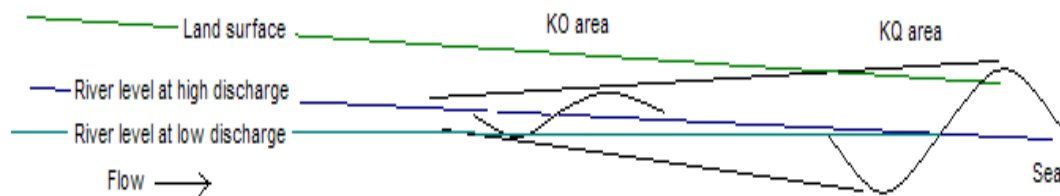
Figure 3. Stronger attenuation of the tidal wave at high discharge compensated by higher river level (compare with figure 2).

In winter and spring, the river discharge is higher, the slope of the water level is steeper and the height of the water level is more (figure 3). Although, at high discharge, the attenuation of the tidal wave is more pronounced, the higher river level compensates this fully.

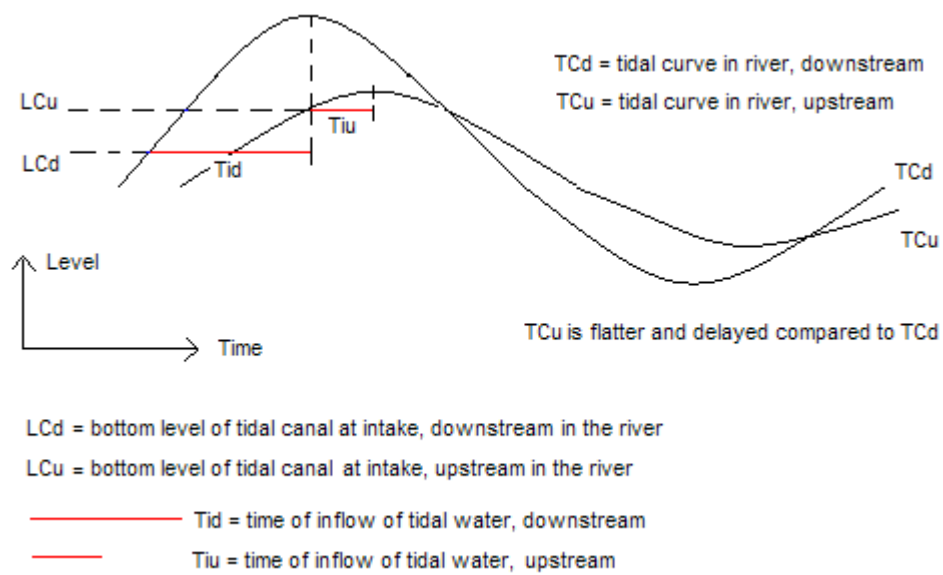
Figure 4. Propagation, attenuation (flattening), retardation (delay) of tidal waves in a river and time of inflow in tidal canals depending on their bottom level and position along the river

The time of inflow into the tidal canals reduces in upstream direction because the tidal wave is attenuated (flattened) and the intake level is higher (figure 4).

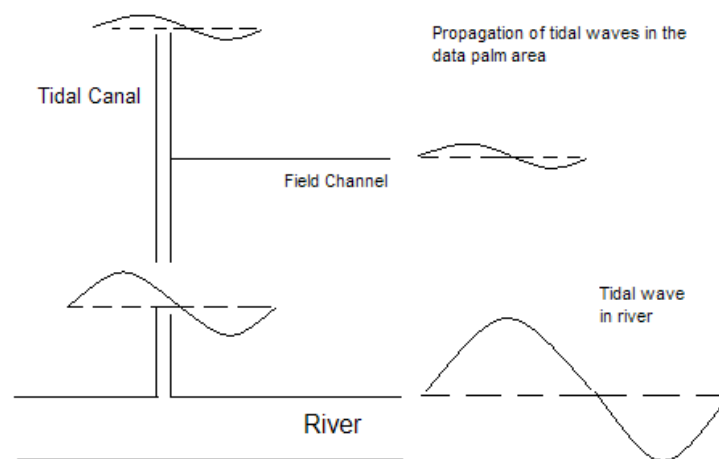
Figure 5. Propagation and attenuation of tidal waves in tidal canals

The tidal fluctuation inside the tidal canals reduces further, because their cross-section is smaller than that of the river (figure 5).

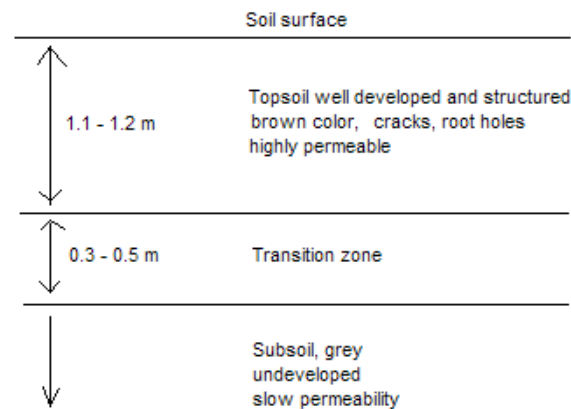
Figure 6. Soil structure with depth in tidal lowlands. The figure shows the conditions in the KO area. Nearer to the sea, in the KQ area, the depth of the developed topsoil is less.

To the contrary, in the upper part of the soil, above mean sea level, one finds cracks, root holes and other biological pores (figure 6). In such conditions the soil is well aerated and has a high hydraulic conductivity. In the KO area the depth of the developed topsoil is more than 1 m, but in the KQ area it is less.

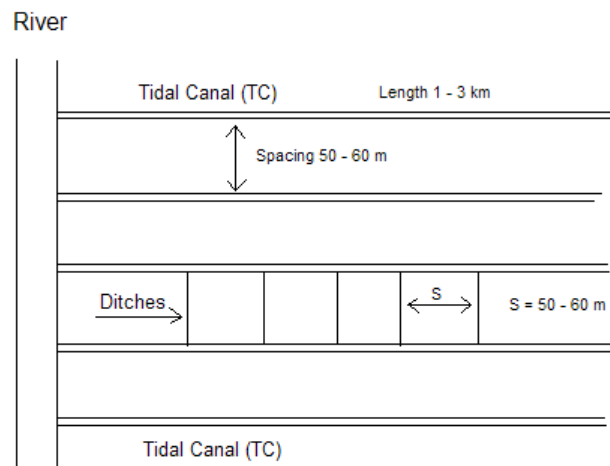
Figure 7. Tidal canals branching off from the river

When levees are present, the depth of the tidal canal should be deeper in the more elevated land. This explains that some tidal canals still function well at a distance of 2 to 3 km from the river or more, where the land level is lower than in the levees. But it also explains that in the convex bends of the river the tidal canals are shorter than elsewhere, because the land level gets higher away from the river due to the existence of natural levees.

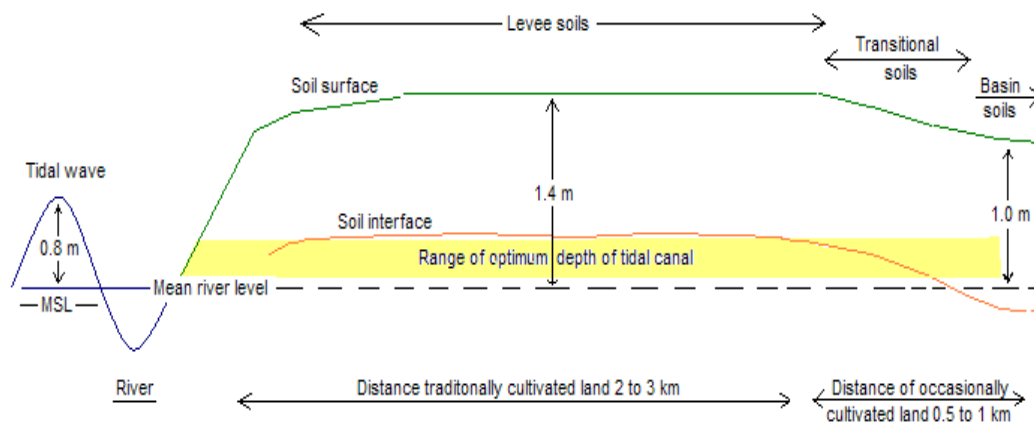
Figure 8. Model of a longitudinal section along a tidal canal and cross-section from the river over the levee into the interior basin area. The soil interface separates the permeable topsoil from the unstructured subsoil. *The indicative measures of the model need to be verified for each tidal canal or group of tidal canals.*

Some TCs are poorly maintained. They have caved in and are overgrown with reeds and weeds. *When a soil reclamation and leaching program is implemented, it is recommended to reshape and clean these canals to secure a proper drainage function during low tide. The depth must be brought to at least 1.2 m below the soil surface (figure 8). The bottom width may be about 1m.*

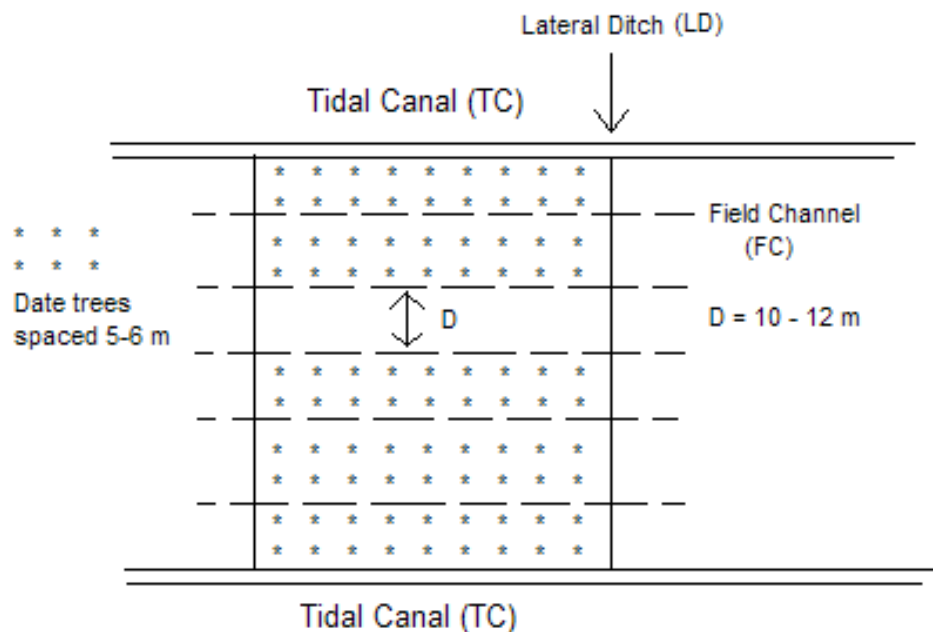
Figure 9. Type 1 layout of tidal irrigation system.

Type 1 layout consists of lateral ditches (LD) perpendicular to the tidal canal (TC) and connecting two neighboring TCs (figure 9). The field channels (FC) that receive the water from the LDs run parallel to the TCs. The distance between the FCs is about 12 m. The palm trees are planted some 3 m from the center of the FCs and the distance between the trees is 6 m.

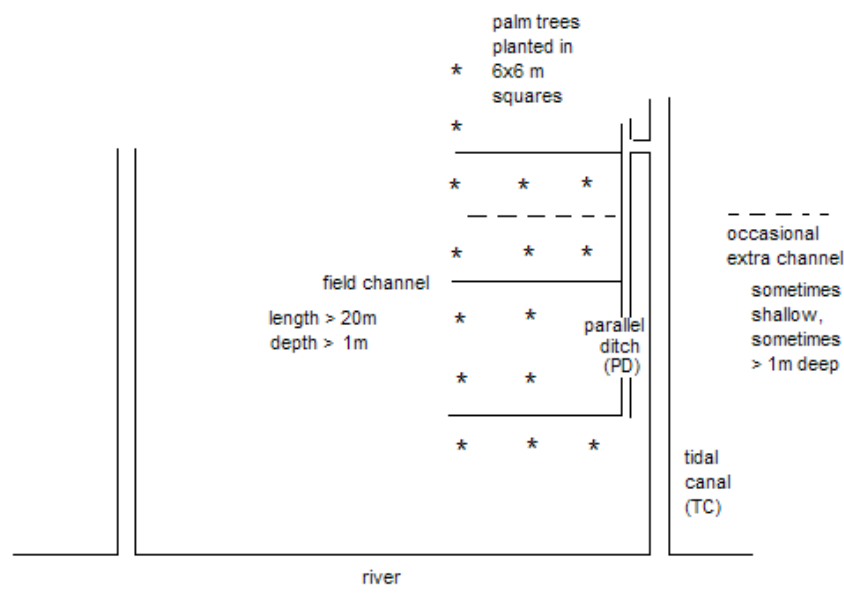
Figure 10. Type 2 layout of tidal irrigation system

The Type 2 layout has a parallel ditch (PD) along the tidal canal (TC) instead of a lateral ditch. The parallel ditch supplies water to field channels (FC) that run perpendicular to the tidal canal instead of parallel as in Type 1 (figure 10).

*It is recommended to leach the abandoned land by installing the Type 2 tidal canal system (see section 9 and figure 10) and providing the ditch with a gate for tidal control (figure 14). The gate must be closed at high tide, to prevent tidal water from entering the field, and opened at low tide, to facilitate drainage of the leaching water applied from the new irrigation systems.*

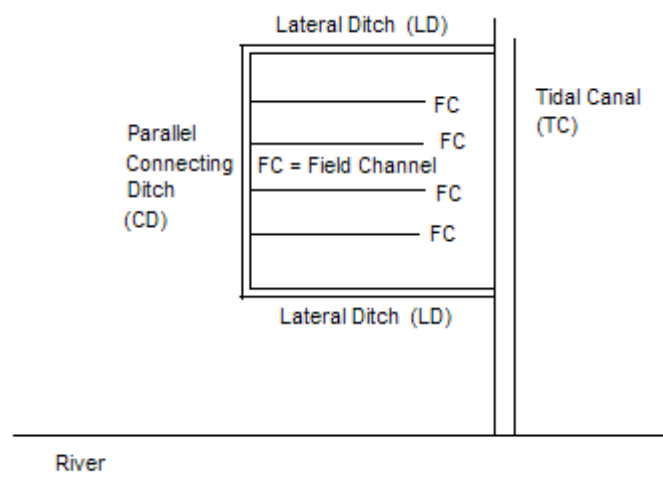
Figure 11. Type 3 layout of tidal irrigation system

In the layout of field channels many variations may be found. As variant intermediate between Type 1 and Type 2 systems like Type 3 (figure 11) also exist.

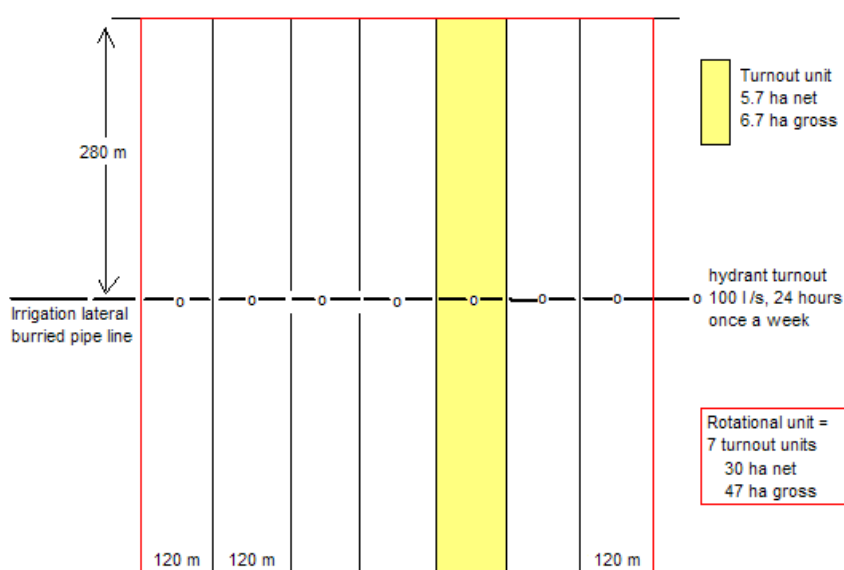
Figure 12. General layout of the new irrigation system within the unit

Each turnout serves a stretch of land of 280x120 m at both sides. It has the capacity to provide 100 l/s during 24 hours, 1 day per week. This amounts roughly to 15 l/s per day or 2.1 l/s per week, corresponding to almost 20 mm/day continuously.

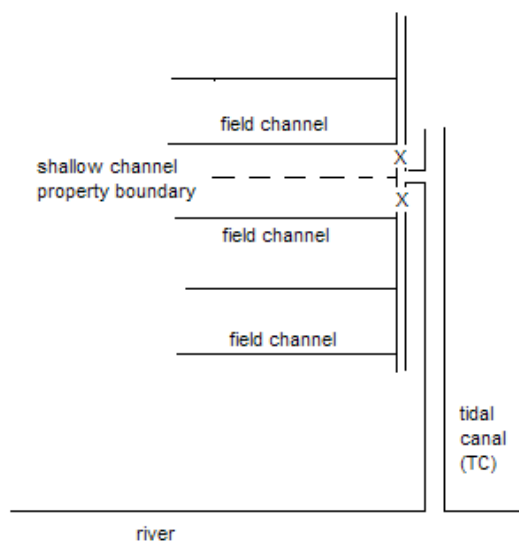
Figure 13. Layout Type 2 with property boundary and two gates

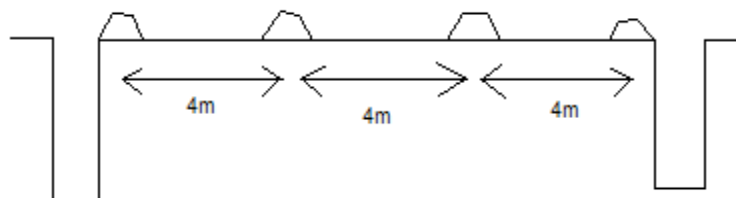
Figure 13. Preparing the field between two field channels for leaching, providing bunds at regular distances.

*To prevent water from flowing over the field surface and draining directly to the channel or infiltrating in the vicinity of the channel, the field must be subdivided by small bunds of 20 to 30 cm height as shown in figure 13.*

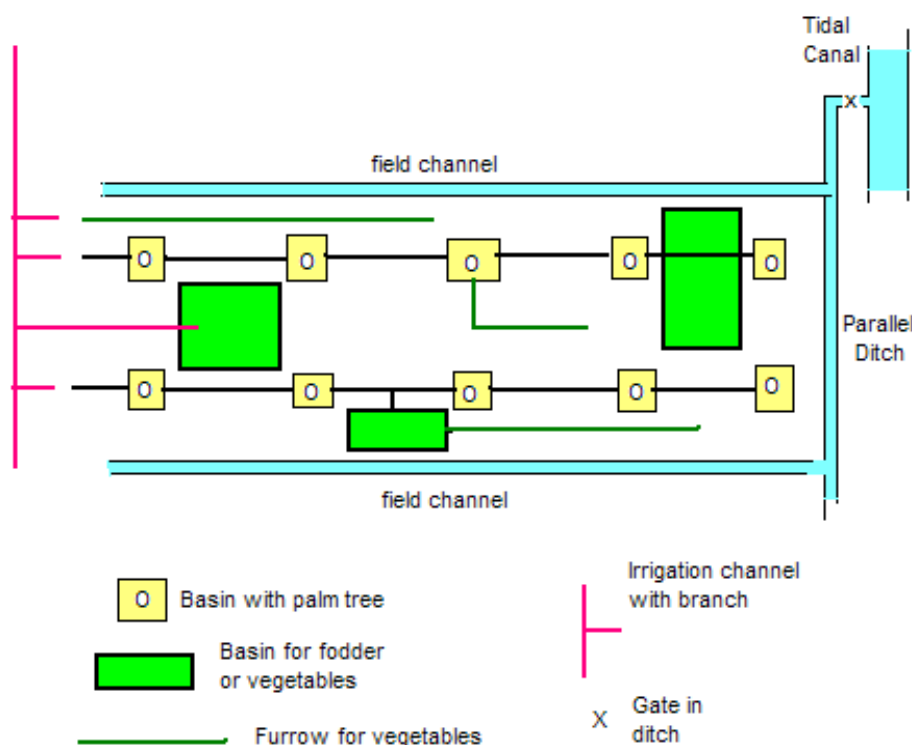
Figure 14. Pilot developments in reclaimed and desalinized abandoned land.

*After reclamation it is recommended to plant pilot palm trees in small basins of say 2x2 m connected with each other by small surface channels and connected to the newly constructed irrigation channel by branch channels (figure 14).*

*In addition to the pilot palm trees one could grow pilot fodder crops (e.g. alfalfa, barley) in extra basins, as shown in figure 14. The location of the extra basins is arbitrary. Also the growing of vegetables in furrows could be experimented.*

The drawing of figure 14 is schematic only and each field may have a different layout. For example one could crop one complete field with barley for fodder, because barley is salt tolerant. Cows are important in the area and there may be need of fodder crops. Therefore, one could also crop one entire field with alfalfa. This crop develops a deep rooting system and may be useful not only as fodder but also to enhance the soil structure.

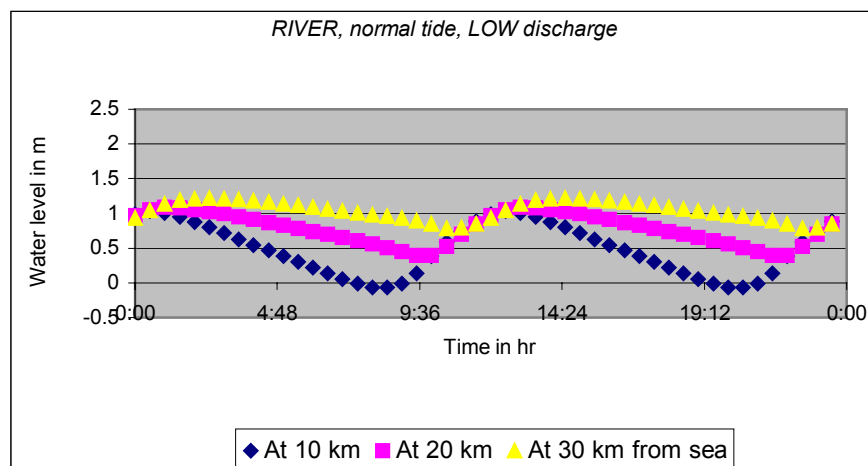
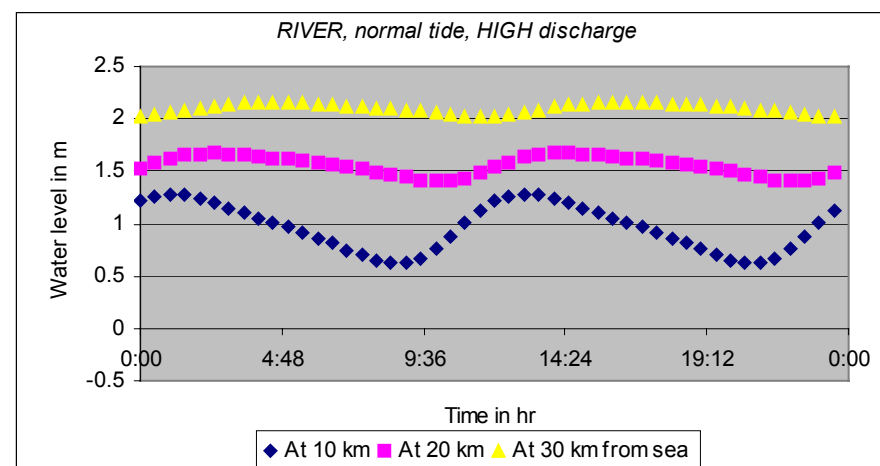
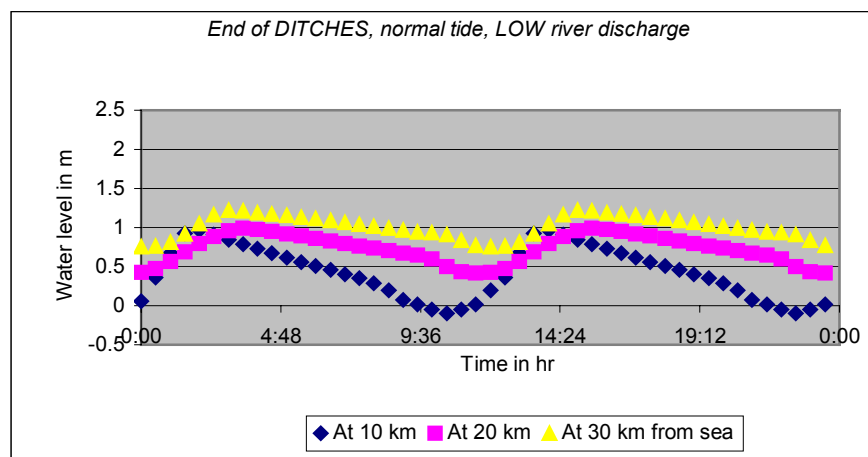
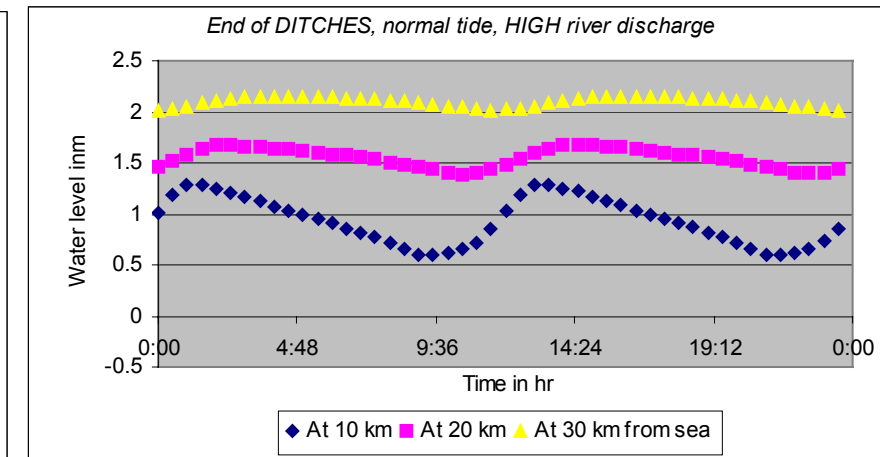
Simulations with Duflow using elementary information of Abadan Island. With more data about topography and river levels (at normal, neap and slack tides, and at normal, high and low river discharge), the simulations can be improved. This is important to establish the optimum depth of tidal ditches. This is important to establish the optimum depth of tidal ditches. The depth depends on the level of the soil surface and on the tidal level. The two conditions must be balanced.

See also the simulations with DuFlow of tidal levels on page 19.
